# Timmerman Lake

Water Quality Report – 2017

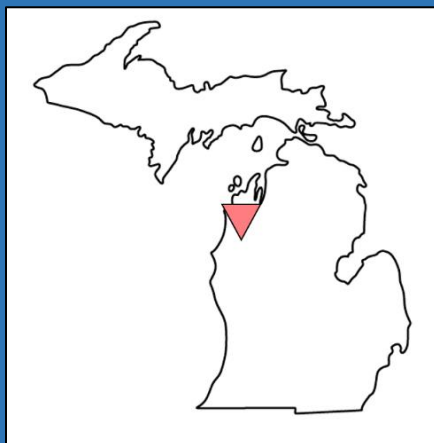
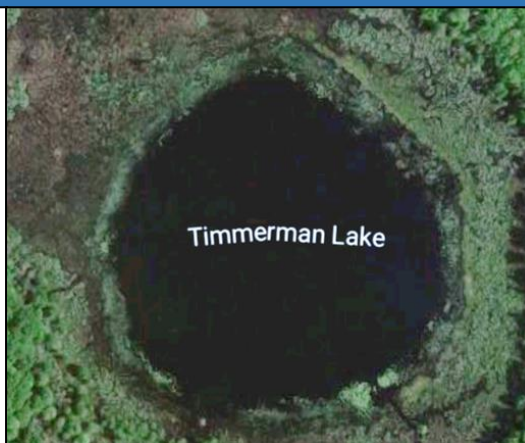
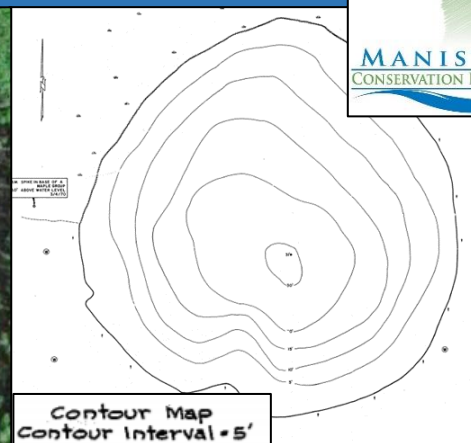
Michigan DNR bathymetric map

Timmerman Lake is located in the northwest portion of Michigan's Lower Peninsula, within the Manistee National Forest. It has a maximum depth of 30 feet and has a surface area of 14 acres. The land surrounding Timmerman Lake is dominated by marsh the soil consists of poorly-drained muck. Great Lakes Restoration Initiative funding was provided by the US Forest Service to complete this project. All data was collected using the Michigan Clean Water Corps' Cooperative Lakes Monitoring Program which enables citizen volunteers to monitor the health of their lakes. To learn more about the CLMP program or any of the water quality parameters used in this report, visit <https://micorps.net/lake-monitoring/>.

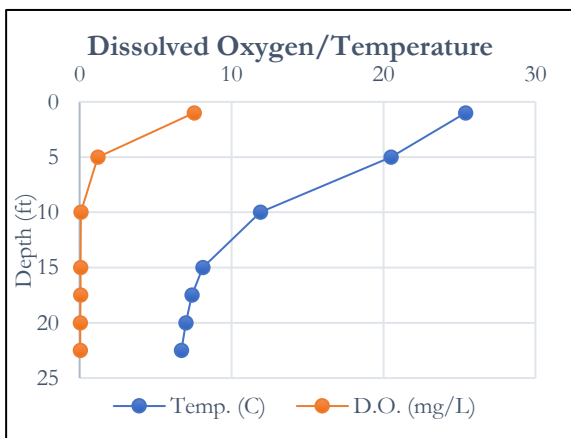
Parameter	# Readings	Min	Max	Average	St. Dev	Carlson TSI
Secchi Disk Transparency (feet)	8	4	7	5.2	1.0	53
Chlorophyll-a (parts per billion)	5	2	9	6.0	2.9	48
Spring Total Phosphorus (parts per billion)	1	38	38	38.0	NA	NA
Summer Total Phosphorus (parts per billion)	1	13	13	13.0	NA	41

With an **average TSI score of 48** based on secchi transparency, chlorophyll-a, and summer total phosphorus, this lake is rated between mesotrophic and eutrophic lake classification. This classification is characterized by having medium/high nutrient content, medium/high levels of algae, and somewhat turbid water. The high level of nutrients in the lake are not caused by human disturbance but rather are the result of the natural process of eutrophication. High nutrient levels result in D.O. being depleted throughout most of the water column for the entire summer. Overall, water quality in Timmerman Lake is good but long-term monitoring is necessary for establishing a baseline and investigating trends.

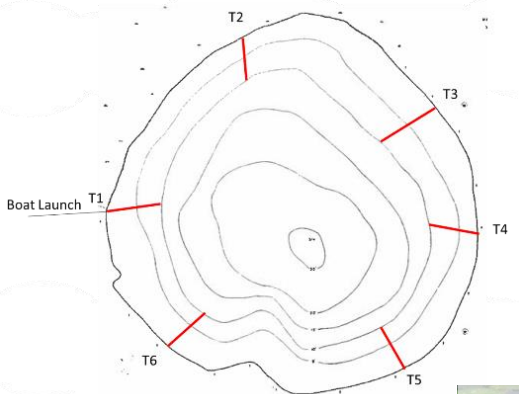
The 2017 Timmerman Lake plant survey resulted in 22 native plant species and zero invasive plant species. Aquatic plants are an essential part of the lake and provide many services including holding sediments in place, reducing erosion and maintaining stability. They also provide habitat and food for many organisms. Overall, List Lake supports a healthy community of native plant species and should be protected from new invasions of potentially harmful invasives.

Plant Name	Density	Rating
coontail	3.20	Heavy
water shield	1.40	Sparse
white water lily	1.33	Sparse
chara	1.07	Sparse
bladderwort	1.07	Sparse
large-leaf pondweed	0.87	Found
flatstem pondweed	0.67	Found
yellow water lily	0.53	Found
pickerelweed	0.47	Found
floating-leaf pondweed	0.40	Found
cattails	0.27	Found
bulrush	0.20	Found
naiad	0.20	Found
willow	0.13	Found
sedges	0.13	Found
arrowhead	0.07	Found
mermaid-weed	0.07	Found
bur-reed	0.07	Found
variable-leaf pondweed	0.07	Found
water horsetail	0.07	Found
water parsnip	0.07	Found
watersmart weed	0.07	Found
