# Dorner Lake

## Water Quality Report – 2017

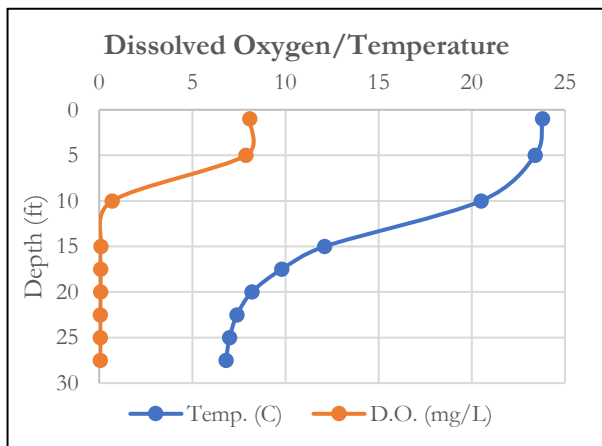
With an **average TSI score of 41** based on secchi transparency, chlorophyll-a, and summer total phosphorus, this lake is rated as a mesotrophic lake. Mesotrophic lakes are characterized by having medium nutrient content, medium levels of algae, and moderately clear water. Dorner Lake keeps some dissolved oxygen in the bottom waters through late spring, but by June the lake has stratified and bottom water is devoid of oxygen.

Overall, water quality in Dorner Lake is good but long-term monitoring is necessary for establishing a baseline and investigating trends.

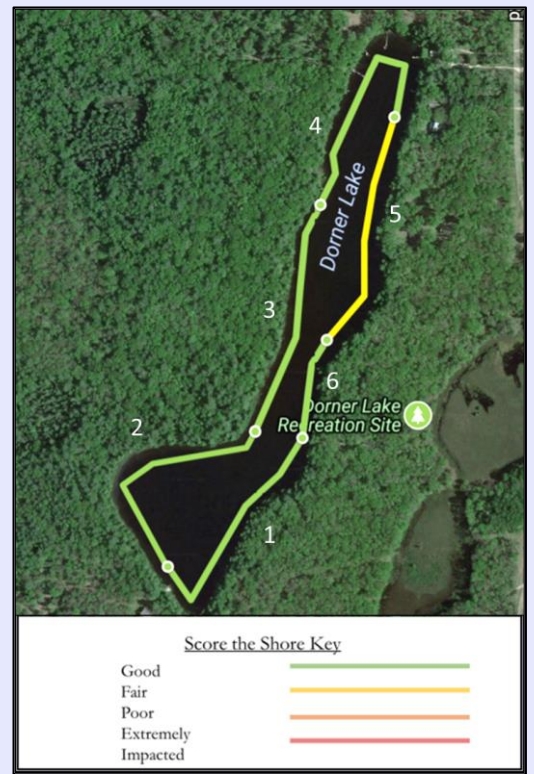
Section	Littoral Zone Score	Riparian Zone Score	Erosion Control Score	Overall Section Score	Section Rating
1	93	91	100	95	Good
2	87	91	100	93	Good
3	93	100	100	98	Good
4	87	82	89	86	Good
5	87	55	78	73	Fair
6	81	91	100	91	Good

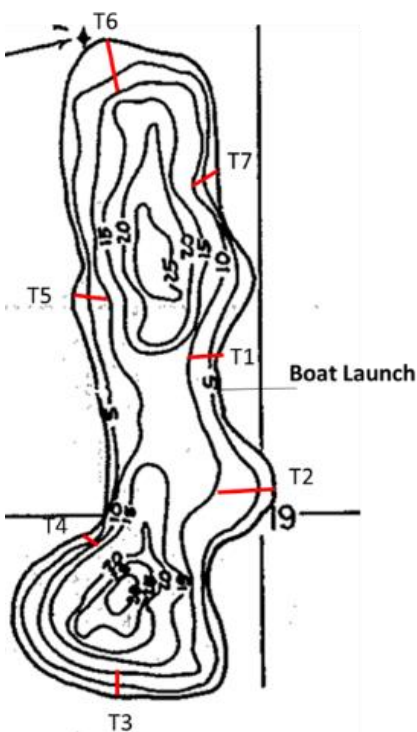
The 2017 Dorner Lake plant survey resulted in 15 native species and only one invasive species (non-native water lily; T7). Aquatic plants are an essential part of the lake and provide many services including holding sediments in place, reducing erosion and maintaining stability. They also provide habitat and food for many organisms. Overall, Dorner Lake supports a healthy community of native plant species and should be protected from new invasions of potentially harmful invasives.

Plant Name	Density	Rating
water bulrush	1.95	Sparse
white water lily	1.67	Sparse
pipewort	1.05	Sparse
bladderwort	0.76	Found
water shield	0.76	Found
riparian fern	0.57	Found
swamp loostrife	0.33	Found
narrow-leaf pondweed	0.29	Found
aquatic moss	0.10	Found
cattails	0.10	Found
nitella	0.10	Found
marsh bedstraw	0.05	Found
non-native water lily	0.05	Found
ribbon-leaf pondweed	0.05	Found
leather leaf	0.05	Found
bur-reed	0.05	Found
