List Lake

Water Quality Report – 2017

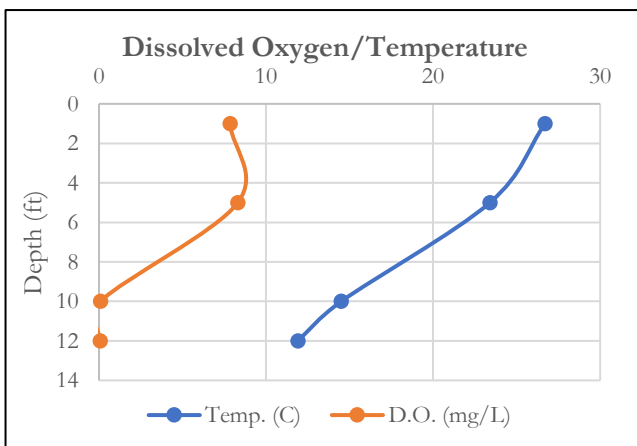
Parameter	# Readings	Min	Max	Average	St. Dev	Carlson TSI
Secchi Disk Transparency (feet)	8	5	7	6.1	0.7	51
Chlorophyll-a (parts per billion)	5	1	9	3.8	3.0	44
Spring Total Phosphorus (parts per billion)	1	11	11	11.0	NA	NA
Summer Total Phosphorus (parts per billion)	1	8	8	8.0	NA	34

With an **average TSI score of 43** based on secchi transparency, chlorophyll-a, and summer total phosphorus, this lake is rated as a mesotrophic lake. Mesotrophic lakes are characterized by having medium nutrient content, medium levels of algae, and moderately clear water. Despite its low depth, the bottom waters of List Lake are devoid of oxygen by early summer.

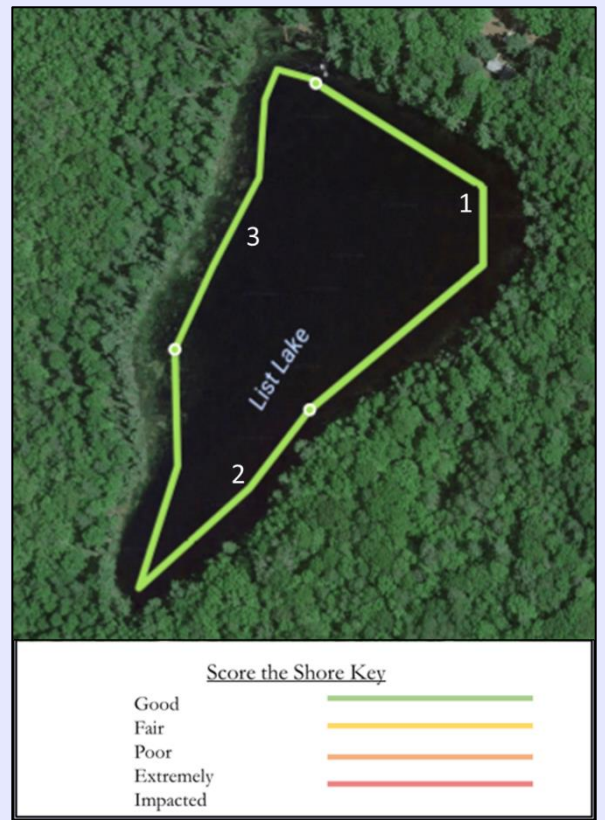
Shorelines are the primary habitat for many animals that live on or near a lake. Healthy shorelines are vital for preventing erosion, maintaining water quality, and slowing and filtering rain runoff. Shorelines are threatened by excessive development including construction of lawns, beaches, and sea walls. Using MiCorps' Score the Shore assessment, each 1000' section of the lake was rated based on three categories: littoral (aquatic) zone, riparian zone (land near shore), and shoreline erosion control practices. All three of List Lake's shoreline sections were rated as Good. To learn more about shoreline health, visit <http://www.mishorelinepartnership.org/>

Section	Littoral Zone Score	Riparian Zone Score	Erosion Control Score	Overall Section Score	Section Rating
1	87	91	100	93	Good
2	87	100	100	96	Good
3	87	91	100	93	Good

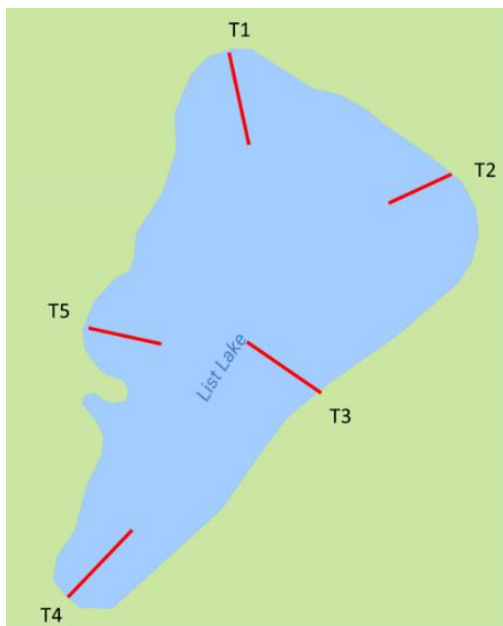
Plant Density Rating

The 2017 List Lake plant survey resulted in 12 native plant species and no non-native species. Aquatic plants are an essential part of the lake and provide many services including holding sediments in place, reducing erosion and maintaining stability. They also provide habitat and food for many organisms. Overall, List Lake supports a healthy community of native plant species and should be protected from new invasions of potentially harmful invasives.

Species	Density	Density Rating
white water lily	2.33	Moderate
watershield	2.13	Moderate
water bulrush	0.80	Found
fern (riparian)	0.33	Found
leather leaf	0.27	Found
sedge	0.27	Found
bog cranberry	0.20	Found
arrowhead	0.13	Found
sphagnum moss	0.13	Found
cattail	0.07	Found
cotton grass	0.07	Found
sundew	0.07	Found

Density	Rating
4 - 5	Dense
3 - 4	Heavy
2 - 3	Moderate
1 - 2	Sparse
0 - 1	Found
